## Selective Soldering Process Development Aided by Solderability Testing

*By Greg Goodell, A.C.E. Production Technologies*

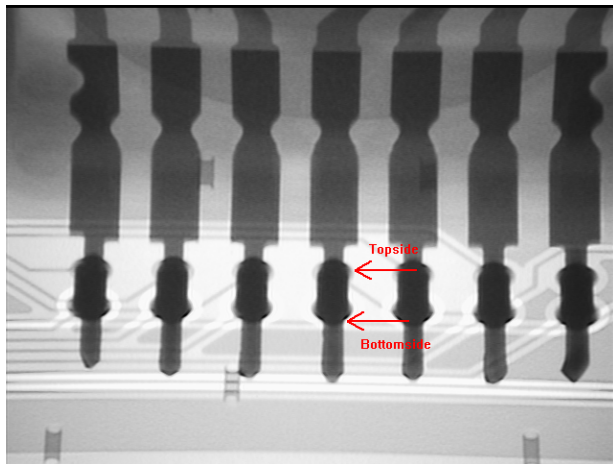
After processing the first board, X-ray images were taken of the barrel fill (**Figure 1**) that looked good for a first attempt, and were assumed easy enough to correct where needed. There were also indications that some adjustments might be needed in order to achieve a proper bottom-side solder shape. We made some adjustments to the flux application, as the shapes led us to believe there was a lack of flux getting to the pins which caused a couple of bridges and "flagging", and ran the same board with these adjustments made, and the bottom-side result was much improved.

**Figure 1:** X-ray after first attempt

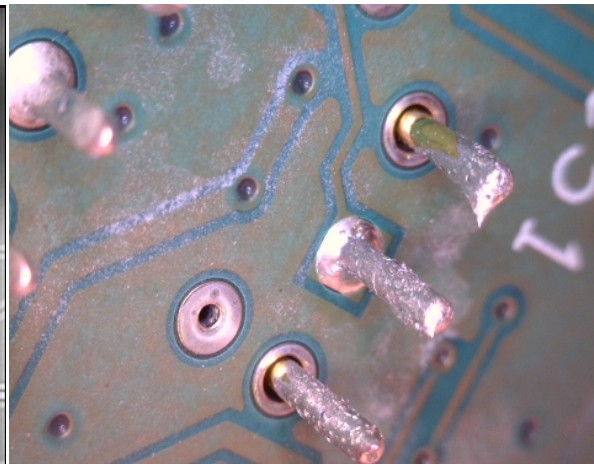
**Figure 2:** Pins showing non-wetting

We then proceeded to the second board using the same program. This process run delivered a nearly identical result to that of the first, showing good barrel fill, but with bottom-side shapes that were undesirable. **Figure 2** shows examples of pins resisting the solder wave almost completely. Only when the wave was able to contact the pad itself did any soldering take place. Based on the X-ray of the

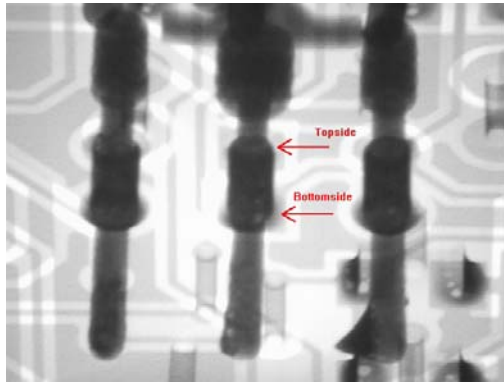
switches (**Figure 3**) which shows voided areas, and significantly, “spotted” areas of the pin where the solder did not adhere, it was concluded that there was a contamination problem. Additionally, we questioned whether or not there was any intermetallic bond created between the solder and the pin.

**Figure 3:** X-ray void and poor pin solder acceptance

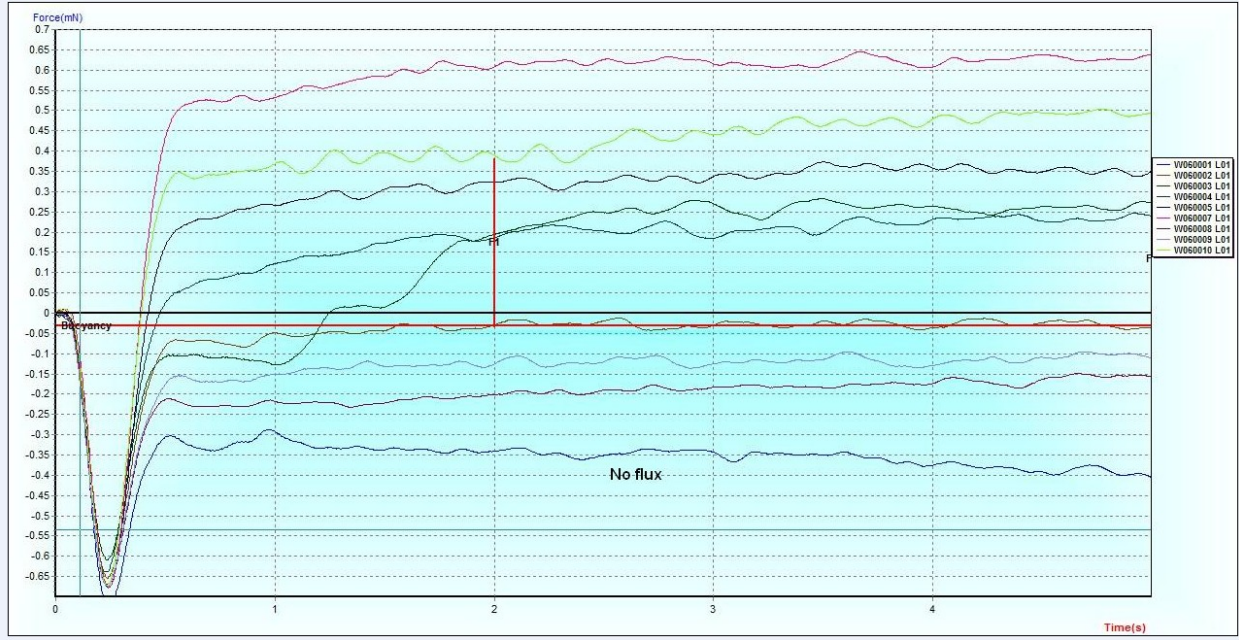
Nine (9) of the pins were tested, and the results recorded (graph, **Figure 4**). No flux was used for the first pin, in order to provide a ‘worst case’ scenario. Then the remaining eight (8) pins were processed using the same flux that was provided for processing the sample boards. As may be seen, most of the pins did not recover beyond the ‘zero point’ or ‘buoyancy’ level, which is the point where the pin stops resisting the solder and begins to be drawn into it. **Figure 5** shows the graph of another set of tests conducted with the exact same parameters and pins from another sample part in the lab’s inventory (not one of this customer’s samples). As may be seen, there is a significant drop in initial solder rejection, as well as attaining “maximum” acceptance within .5 second. We then re-tested the four weakest results (**Figure 6**) from the first graph, which proved that the newly-tinned pin accepted solder much better, closer to what it should, thus proving that the plating condition was responsible for the bottom-side shape problems.

**Figure 4:** Initial part testing of nine (9) pins

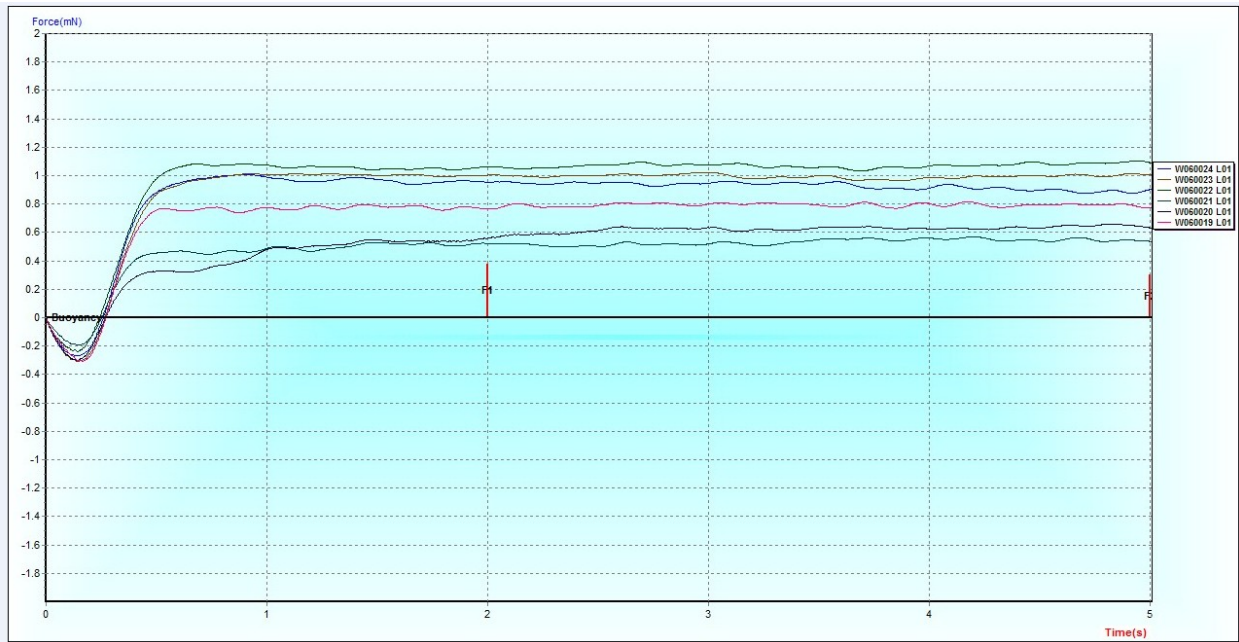
**Figure 5:** Testing of similar pins with identical parameters

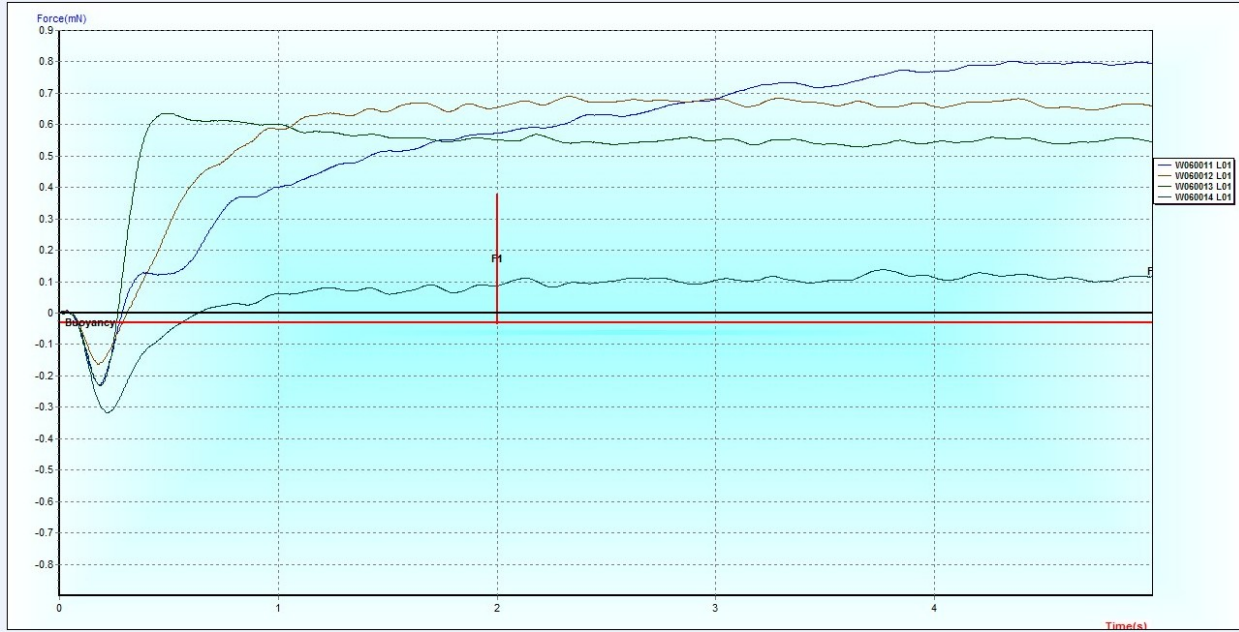
**Figure 6:** Retest of four (4) weakest pins
